Engineering Geological Investigation of the Lake Coleridge Rock Avalanche Deposits, Inland Canterbury

A thesis
submitted in partial fulfilment
of the requirements for the degree
of
Master of Science in Engineering Geology
at the
University of Canterbury
By
Jenny Alice Lee

Department of Geological Sciences
University of Canterbury
December 2004

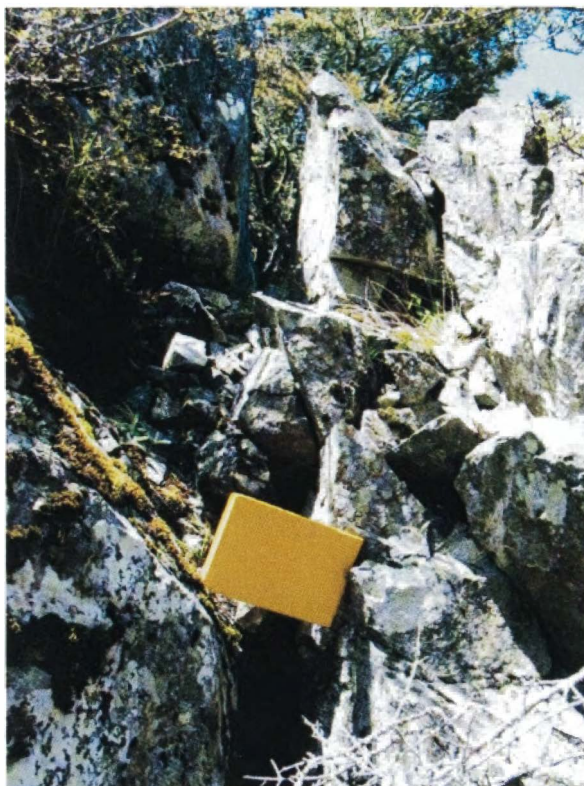
Figure 2.4: “Relaxation” of joint within Torlesse Supergroup greywacke located on the northeastern section of the head scarp of Carriage Drive. The orientation of the joint is (028/76°E). Slope falls away from left to right.

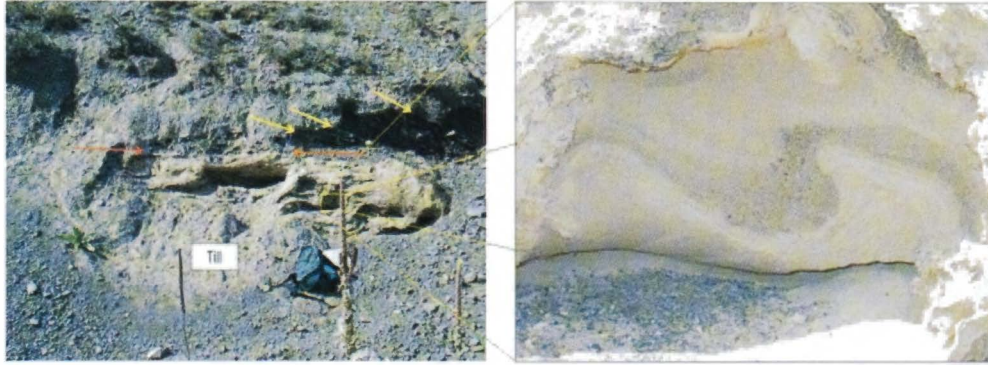
Figure 2.8: Deformed lake sediments exposed on the true left bank of Ryton River ~1 km upstream from the Ryton Bridge. Yellow arrows indicate foreset beds in overlying gravels, while orange arrows indicate planed surface directly above soft sediments. Note the backpack for scale.

Fine sediments of sand and granule size, located further upstream within the Ryton River (grid reference K35: 927697), also on the true left, are contorted and deformed (figure 2.8). GPS surveying showed that the sediments were at an elevation of 557 ± 1 m, and are therefore not associated with the “Greater Lake Coleridge”. Glacial tills overlie the small ‘pocket’ of fine sediment. SOONS (1963) highlights the tendency for lake silts in the Rakaia Valley to be contorted in character, suggesting that their depositional environments were in a number of ice-marginal lakes relating to different ice advances, particularly in retreat stages, and not in one continuous lake. The deformed sediments identified within the Ryton River are thought to be ice-contact deposits that have been deformed, due to excess pore pressure and water escape, caused by overburden pressures and/or effects of readvancing ice and till.

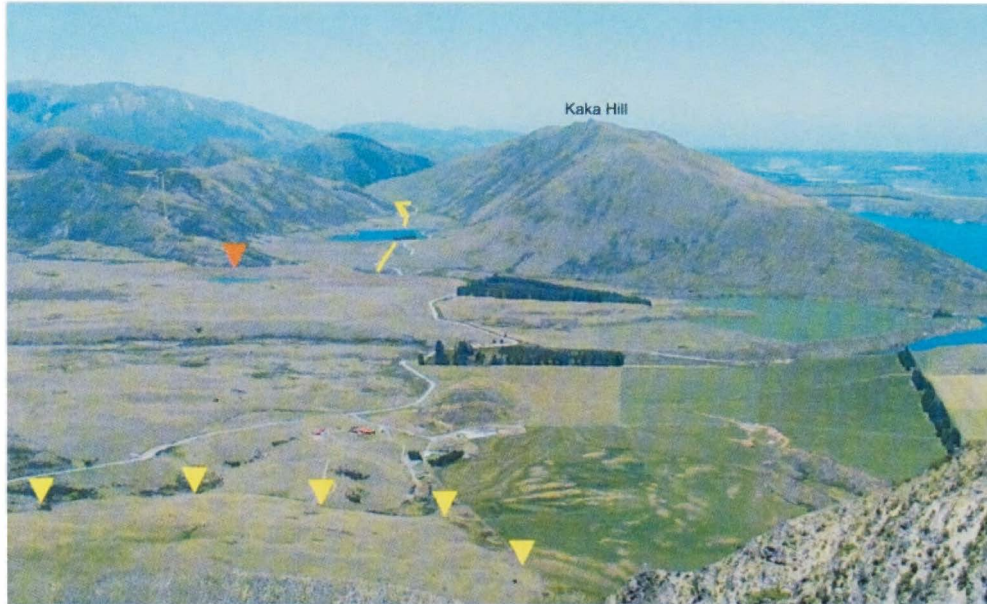
Figure 2.9: View to the south looking at the Kaka Hill meltwater channel (highlighted by yellow arrow in background) which transferred Acheron 3 glacial meltwater out of the valley. Lake Georgina (located within broken section of arrow) is located within this meltwater channel. A kettle lake is visible (highlighted by the orange arrowhead). The outline for the LCRA1 is shown with the yellow arrowheads. Photograph taken from top of Carriage Drive. Lake Coleridge is just visible to the right of the photograph.

During SOONS' (1963) study of the glacial sequence of the area, meltwater channels were identified (Appendix D), two of which are located towards the southeastern edge of the present field area (figure 2.5). The first is located on the northeastern side of Kaka Hill (figures 2.5 and 2.9), where waters flowed to the northeast of Mt Barker, before draining down towards the south and joining water within the Rakaia riverbed (figure 2.5). The second is a meltwater channel that has eroded the Acheron 3 terminal moraine at the south-eastern end of Lake Coleridge, between Mt Barker and Lake Hill. The meltwater channels during the Acheron Advances are believed to follow drainage established during earlier advances, with minor exceptions such as the channel through Acheron 3 terminal moraine (SOONS, 1963). The two meltwater channels that have been mentioned both lack stream flow at the present day.

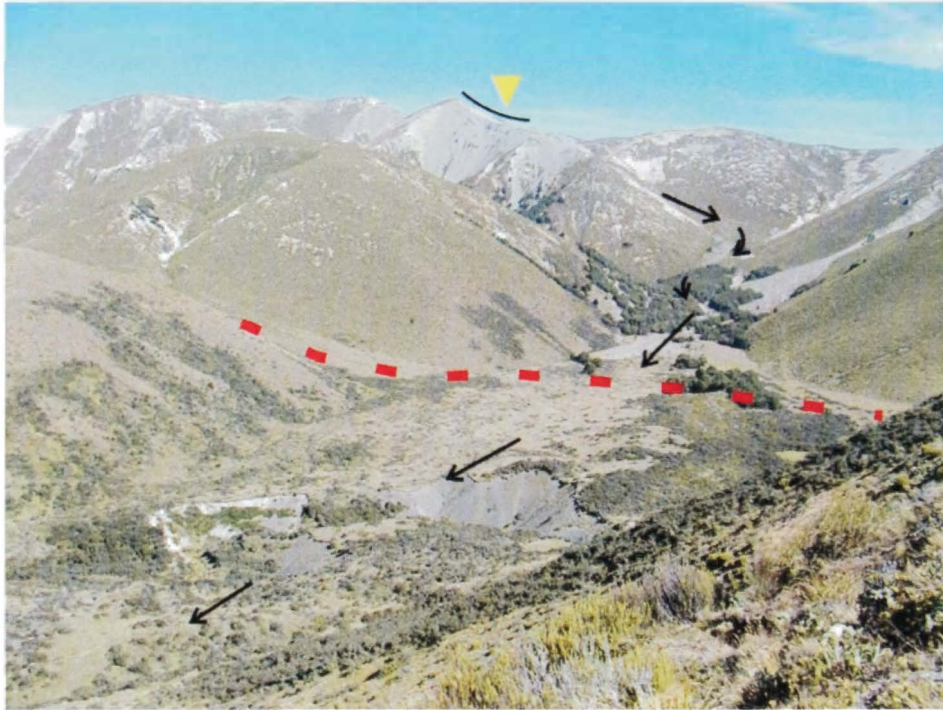
Figure 2.14: Photograph of the Acheron Rock Avalanche deposit. Source area is a bowl-shaped feature located behind the ridge indicated by yellow arrowhead and curved black line. The deposit ramps up on either side of the narrow valley, before continuing down valley (indicated by black arrows). The Porters Pass Fault is indicated by the dashed red line. Deposit continues down valley for another ~500 m. Photograph taken by Dr T. DAVIES, University of Canterbury, 2003.

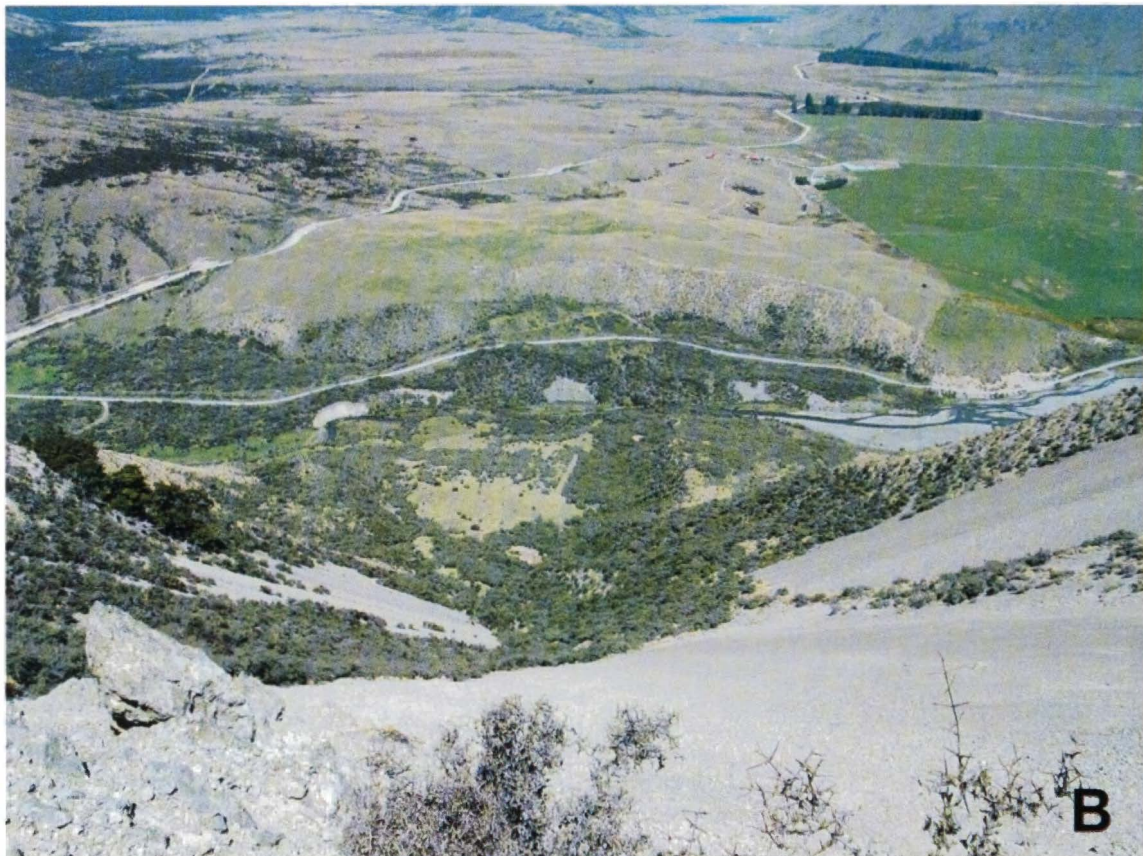
Figure 2.15: Opposite Page: A) Features seen from top of source area, which include LCRA1, LCRA2 and LCRA3 deposits (see legend above). B) Corresponding photograph taken looking down the valley (towards the southeast).

The LCRAD is the focus of this study. The deposit is located on Ryton Station, near the mouth of the Ryton River where it flows into Lake Coleridge (figure 2.15). The deposit was originally identified in the regional rock avalanche study by WHITEHOUSE (1981), who called it the Lake Coleridge rock avalanche deposit. WHITEHOUSE'S (1981) study found that the deposit covered an area of $23 \times 10^4 \text{ m}^2$, had a thickness of 20 m, and a volume of $4 \times 10^6 \text{ m}^3$. A weathering rind survey, using the method outlined by CHINN (1981), was conducted at an undefined location on the surface of the deposit and gave an age of 120 years B.P. (WHITEHOUSE, 1981).

The present study has identified three individual rock avalanche deposits within the Lake Coleridge rock avalanche. They have been assigned numbers in chronologic order and have been named the LCRA1, LCRA2 and LCRA3 deposits (figure 2.15). A cirque-like head scarp on the southern face of Carriage Drive is the source for the three rock avalanche deposits that are located at the foot of Carriage Drive. A description of the three rock avalanche deposits is given in Chapter 3. The LCRAD material is sourced from Torlesse Supergroup “greywacke” and therefore, in composition, is the same as the valley floor tills and gravels. The highly fragmented, fractured angular clasts of the rock avalanche deposit, however, differentiate readily from the sub-angular to sub-rounded glacial tills and river gravels located on the valley floor.

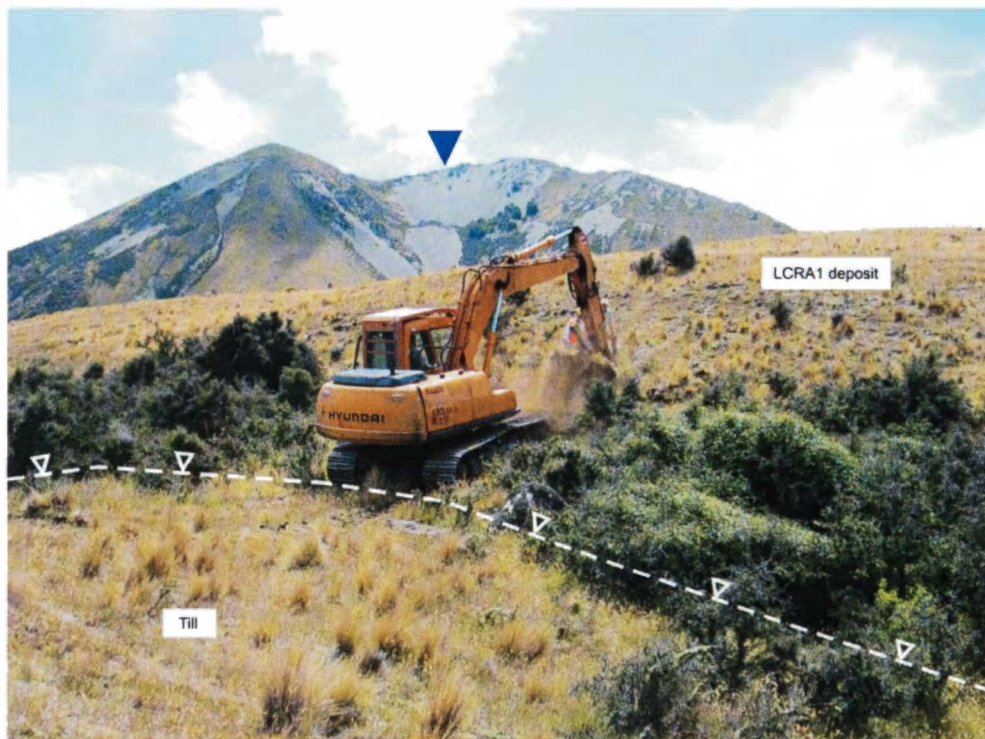
Figure 3.10: Excavation of T₁ into LCRA1 deposit. The white dashed line indicates the change in slope at the rock avalanche edge onto glacial till. Carriage Drive, the source area, is indicated with a blue arrowhead. Photograph taken looking north.

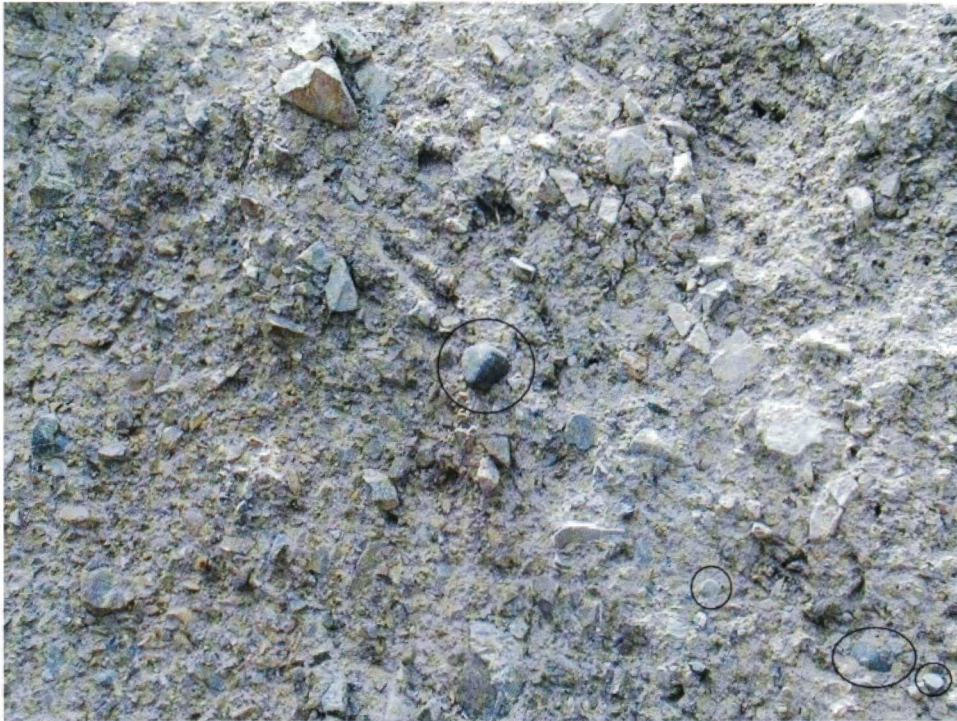
Figure 3.14: Rounded clasts (highlighted by black circles) within the probable lowest 1 m of the LCRA2 deposit. The majority of the clasts display angular corners signifying break-up and fragmentation (fracturing) during transportation of the rock avalanche. Photograph taken by Dr T. DAVIES, University of Canterbury, 2003.

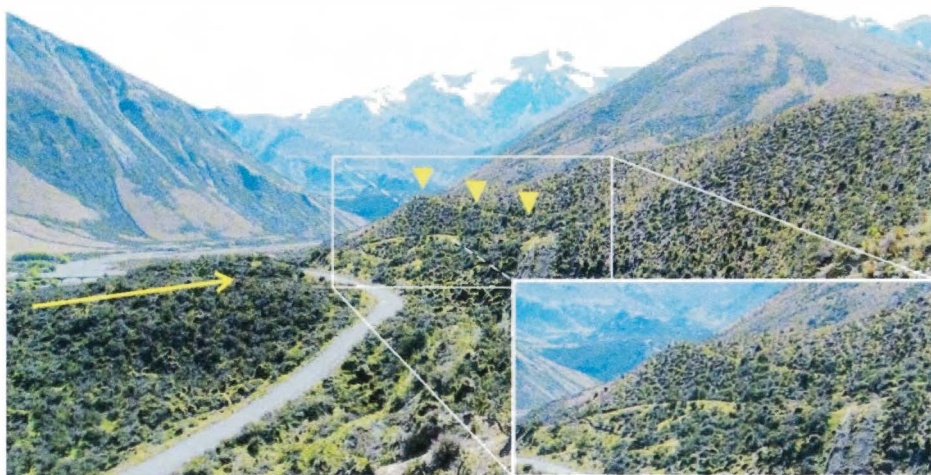
Figure 3.15: Brandung feature (with inset) of the LCRA2 deposit. The rock avalanche debris has partially "climbed" the LCRA1 deposit, essentially wrapping around the pre-existing topography. The brandung is highlighted by the yellow arrowheads, while the yellow arrow indicates flow direction of the rock avalanche debris from the LCRA2 event.

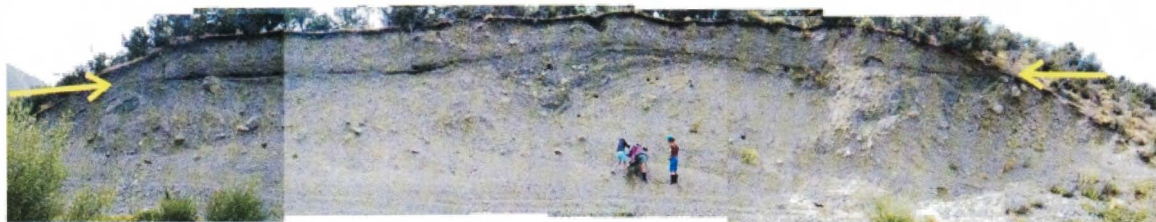
Figure 3.16: Cliff exposure of LCRA2 deposit. Photograph taken looking southeast with source area directly behind. The contact between LCRA2 and LCRA3 is visible near the top of the cliff (shown with yellow arrows). Note people for scale. Photograph taken by Dr T. DAVIES, University of Canterbury, 2004.

As shown in figure 3.16, internally the rock avalanche deposit is chaotic, which is a common feature (MITCHELL *et al.*, 2001). It is matrix-supported with a large percentage of fines (pebbles to fine sands), while larger angular sandstone clasts are spaced randomly throughout. Very little structure is visible within the lower portion of the section, but towards the top faint alternating pseudo bedding or lenses of sandstones and mudstones are present (figure 3.17). This type of layering is a characteristic of rock avalanche deposits and is often titled “inverse stratification”. Examples include the famous Blackhawk landslide of SHREVE (1968), and the Acheron Rock Avalanche located in the neighbouring valley (SMITH, 2003). SHREVE (1968) noted that the detailed stratigraphy within distal portions of the Blackhawk landslide indicated almost laminar flow of the deposit during transportation. The pseudo-bedding or laminations identified within the cliff section of the LCRA2 deposit were also identified within Trench 3 (T_3) excavated into the deposit (Section 3.4.3.1).

- The LCRA3 deposit directly overlies the LCRA2 deposit. Although it is very small for a rock avalanche, with only ~2 m thickness both at the cliff exposure (figure 3.16) and at the T₂ site, it shows a very chaotic structure. This in part is assigned to the presence of a large Torlesse sandstone boulder ~1 m in diameter, which is believed to have distorted the inverse stratification of the lenses of sandstone and mudstone-rich matrices.
- Topsoil (ranging from 5 cm to 20 cm) has established a cover over the LCRA3 deposit.

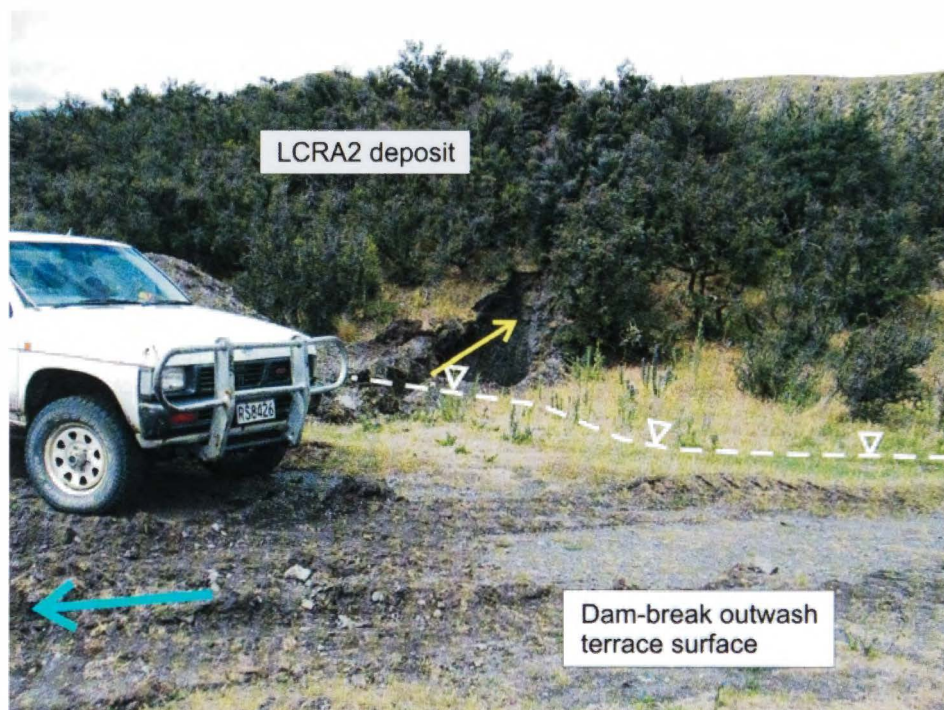
Figure 3.18: Photograph of T₃ site. The white dashed line indicates the change in slope between the LCRA2 deposit and the dam-break outwash terrace surface in the foreground. The trench is highlighted with a yellow arrow, while the source area direction is indicated with the aqua arrow. Photograph taken looking southeast.

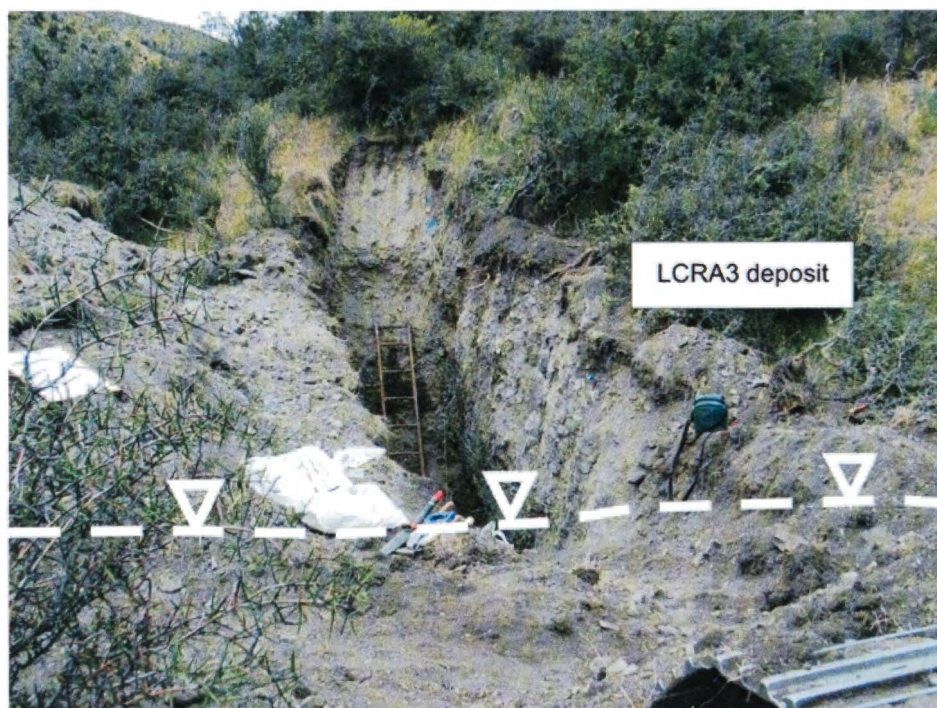
Figure 3.20: Photograph of T₂ site. The white dashed line indicates the change in slope believed to be the contact between the LCRA2 and LCRA3 deposit. However after logging the face this was found to be not the case (figure 3.21). Ryton Bay Road is located to the left of the photograph approximately 3 m out of the view. Photograph taken looking southwest.

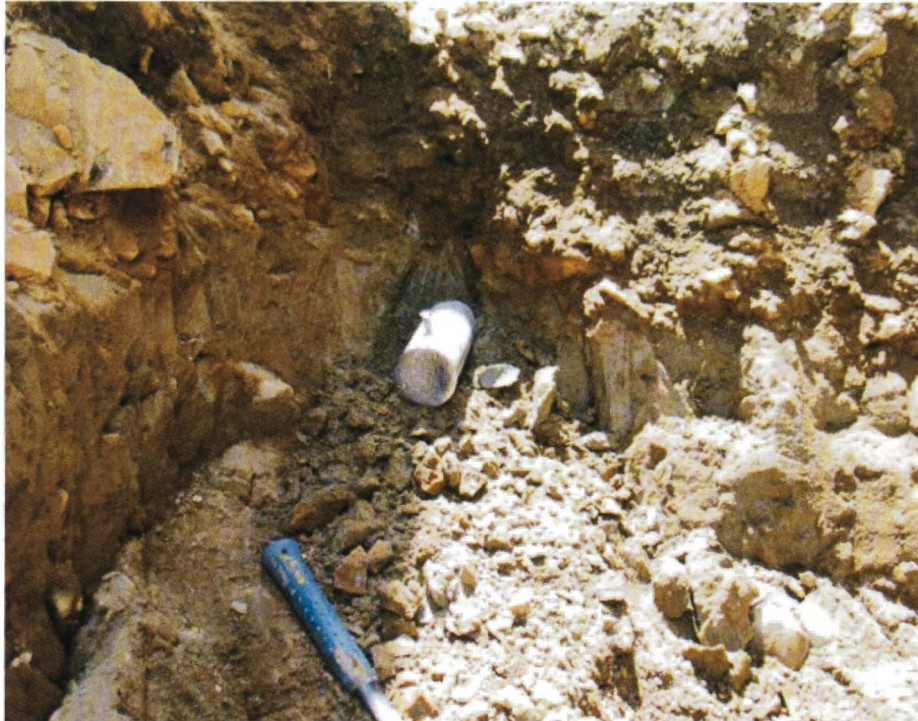
Figure 4.4: Luminescence sampling in trench face (T₄). Sample tube has been hammered into soft sandy “loess”, and is about to be extracted, with the sampled soil coming away within the tube.

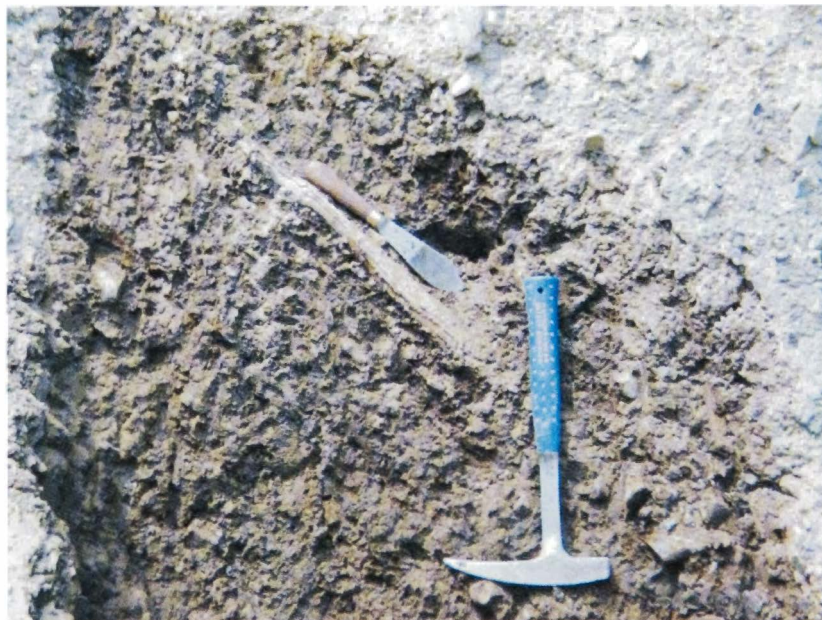
Figure 4.9: Mānuka sample found in LCRA2 debris within a cliff face eroded by the Ryton River. Refer to figure 4.8 for location. Geological hammer for scale.
